# Dickinson Bay Island II: A Restoration Success Story in the Texas Gulf Coast.

By Angie Quiroga Torres – Environmental Scientist

# Dickinson Bay Island II

Galveston County, TX

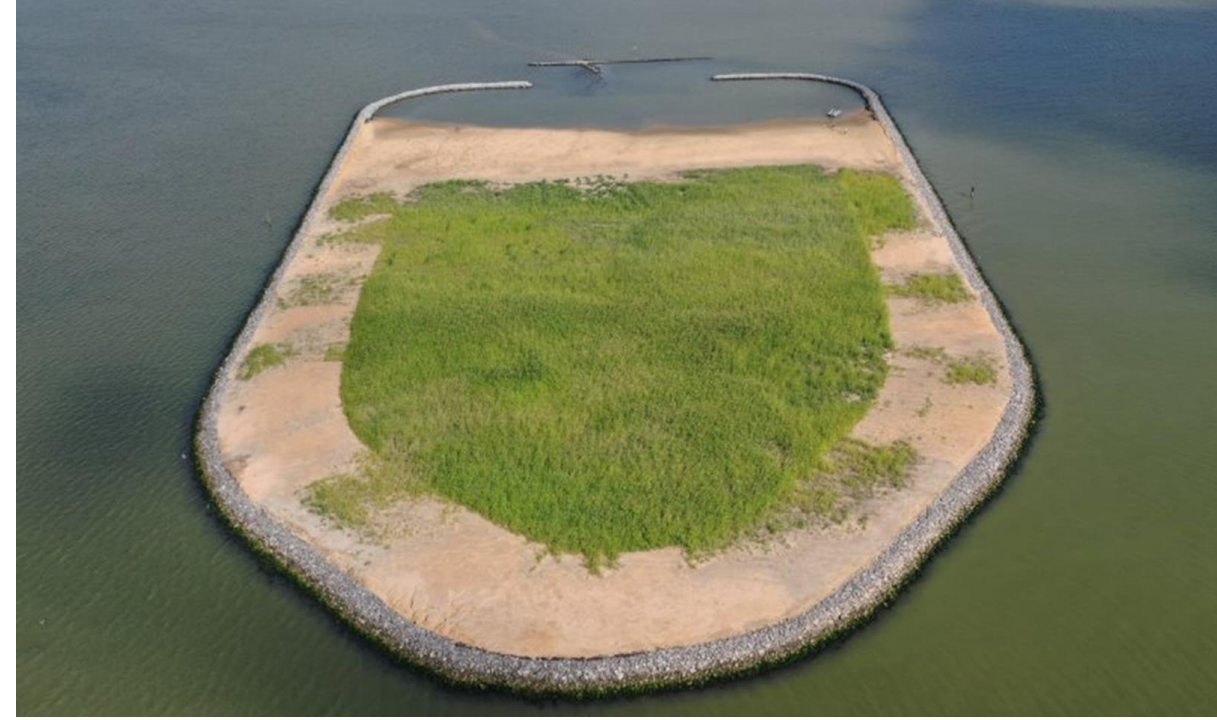
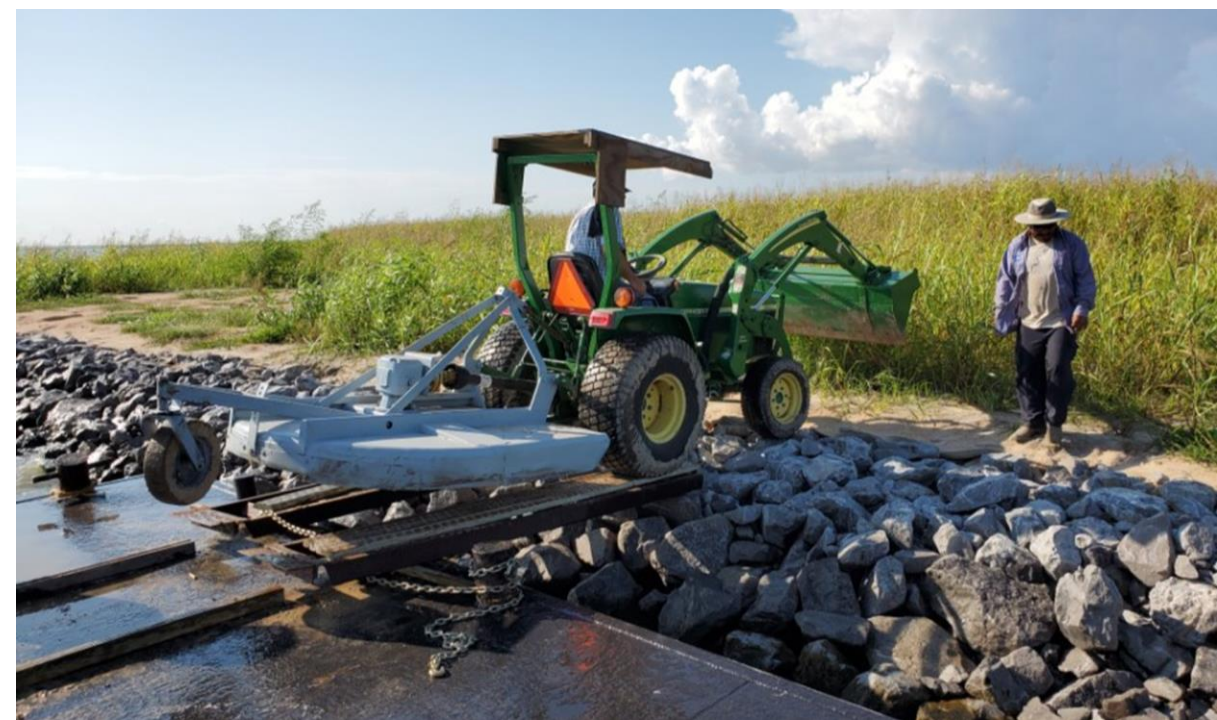
Johnson Grass at about 10 feet in height!
